BUILDING SCIENCE SERIES 40

Engineering Aspects of the 1971 San Fernando Earthquake

This report presents the observations of the NBS on-site inspection team (most photographs in this report were taken by the team). The material presented herein is intended to serve as (1) a documentation of damage resulting from the earthquake and (2) as a source document for further studies, research, and recommendations. This is particularly important as necessary remedial work and restoration have resulted in the removal of evidence that is essential for studies and evaluations.

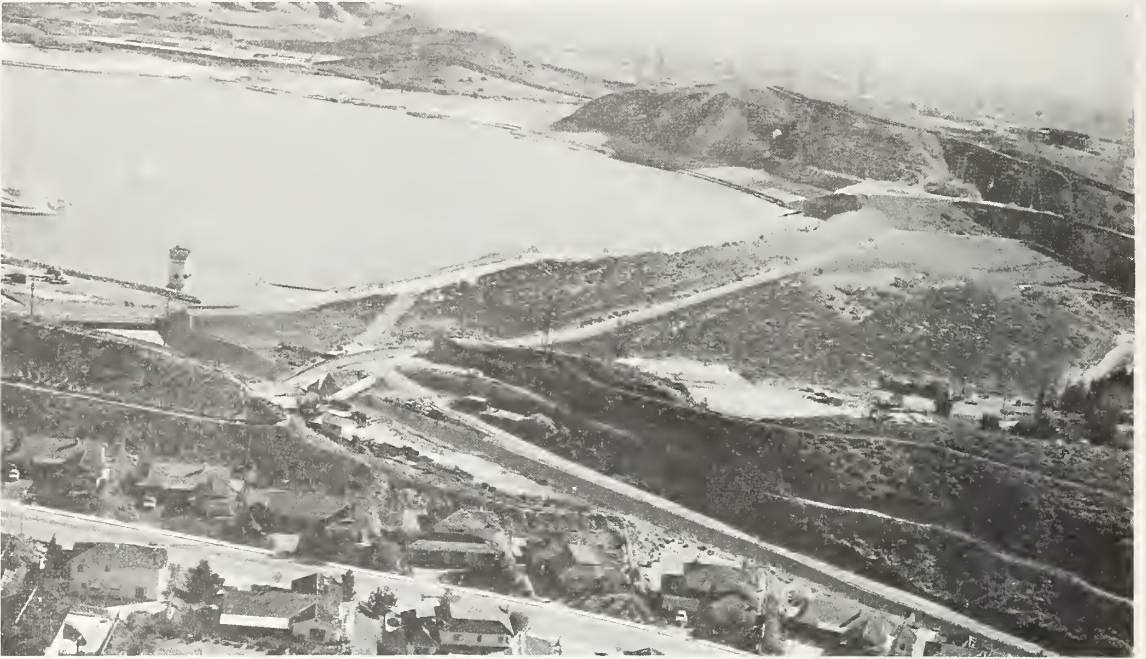
Aerial views of the Lower Van Norman Dam taken after several days of pumping to lower the level are given in figures 4.4, 4.5, 4.6 and 4.7. Figure 4.4 is a view of the Lower San Fernando Dam taken from downstream and clearly indicates the degree of collapse of the main fill over a great portion of the width of the dam. Water level was almost at the height of the lowered crest on the right side of the dam as viewed in this photo. Figure 4.5 is a similar photo taken from upstream and shows both the collapsed concrete liner and the large number of residences in the downstream flood plain. Figure 4.6 is taken from upstream and shows a relatively close-up view of the failure near the east abutment. Original height was at the level of the roadway on the crest. Figure 4.7 shows the degree of failure of the earth dam and the concrete liner.

Figure 4.4 Lower San Fernando Dam after lowering of water level.

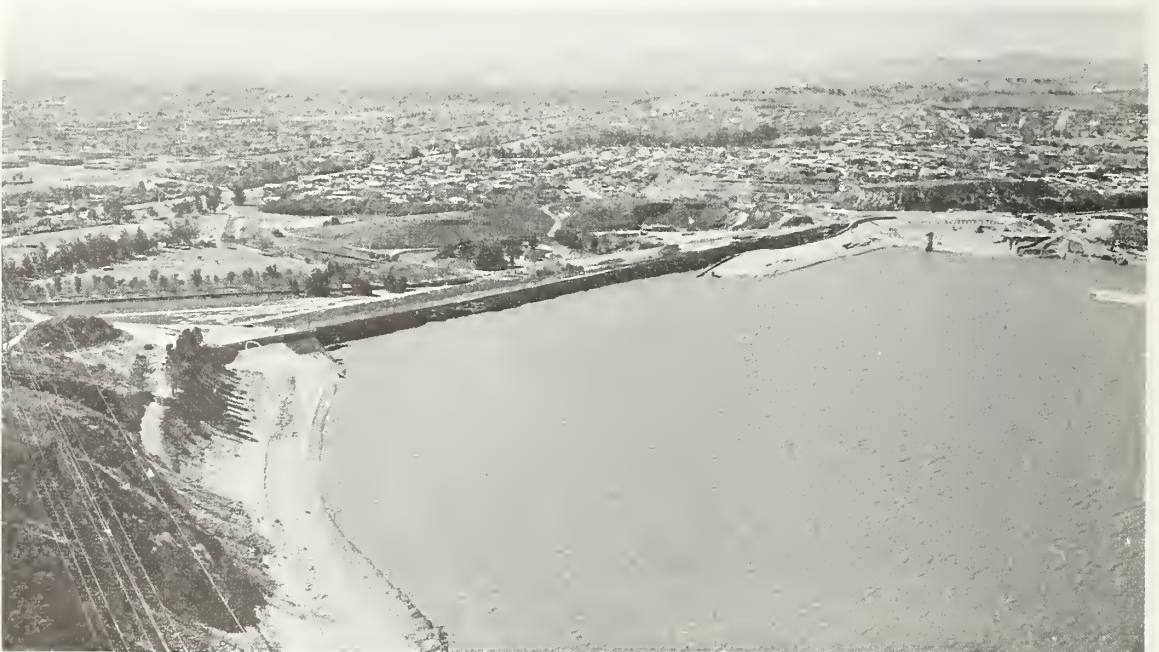
Figure 4.5 Lower San Fernando Dam and endangered residential area.

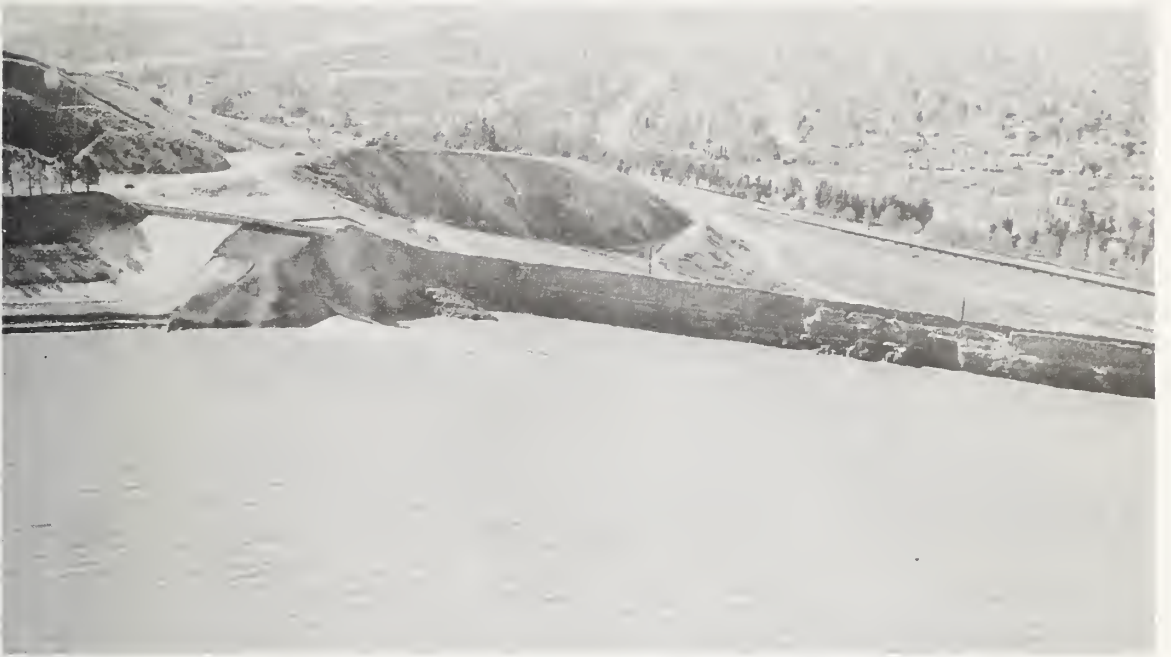
Figure 4.6 East abutment of Lower San Fernando Dam.

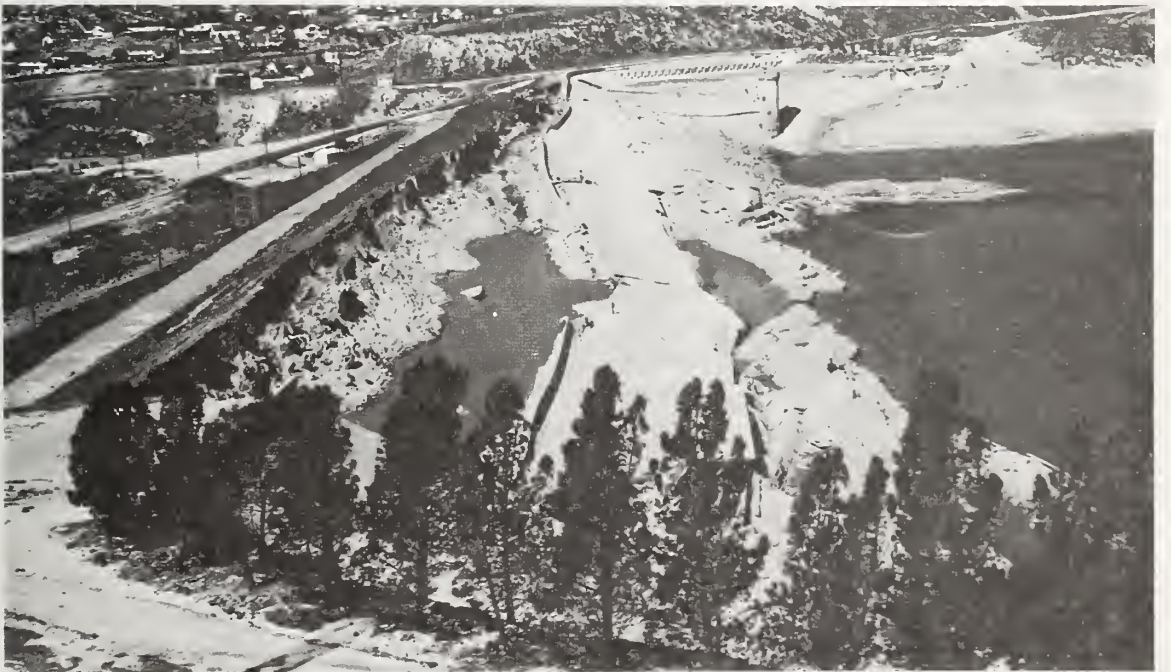
Figure 4.7 Collapsed liner of Lower San Fernando Dam.

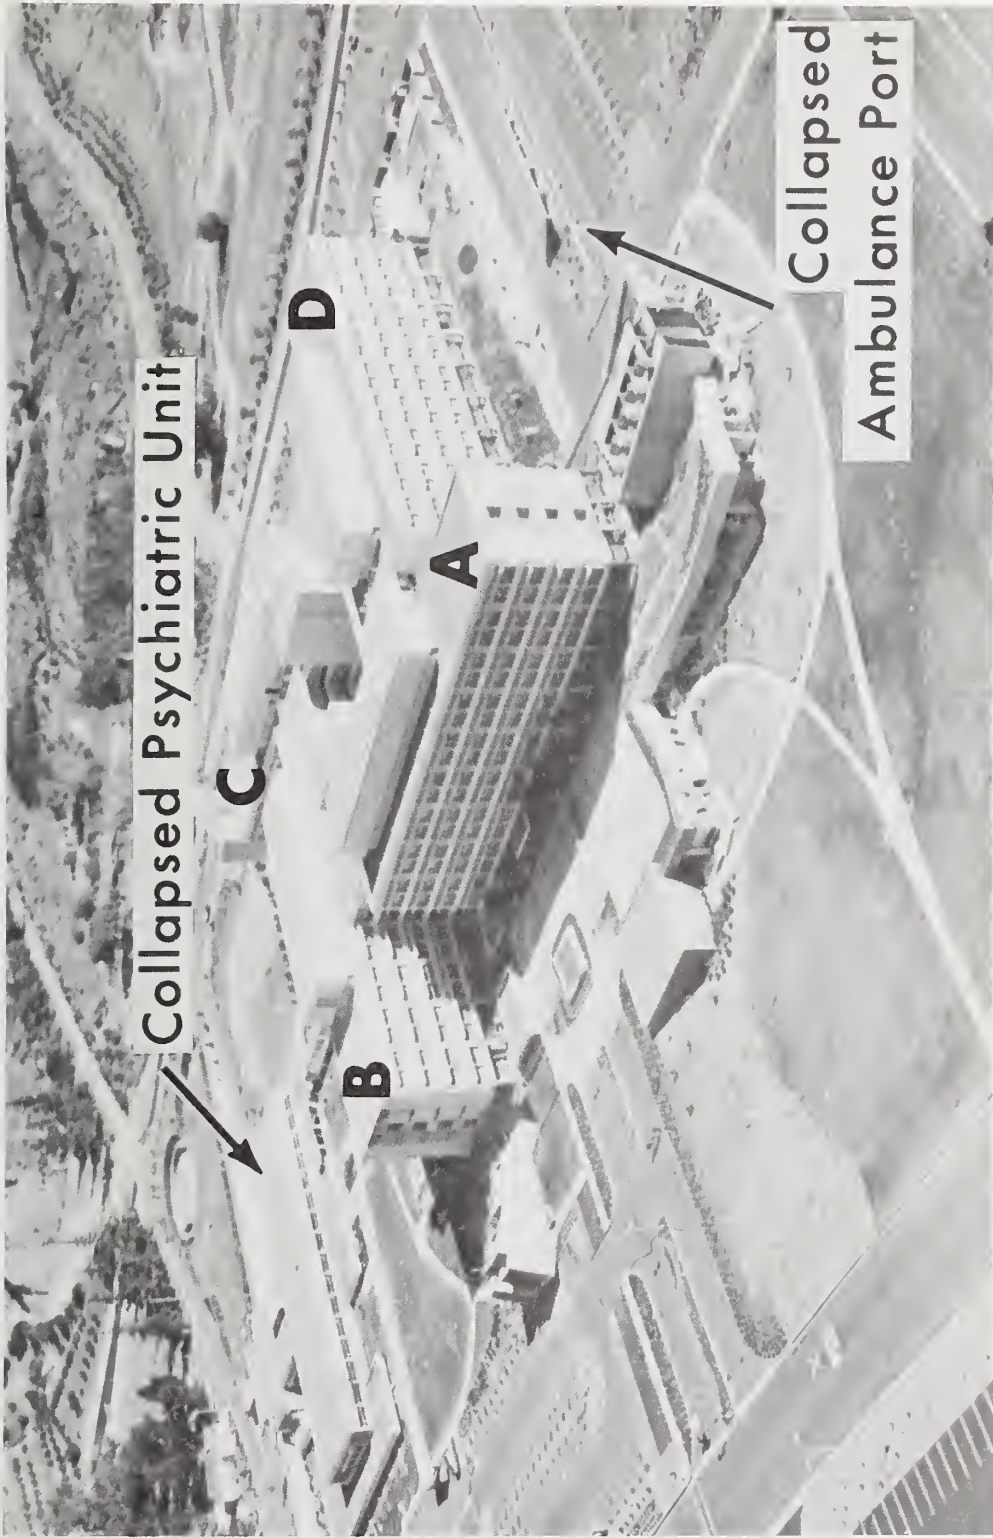
Figures 5.7 and 5.8 are photographs taken before and after the earthquake, similar to figures 5.5 and 5.6, except that the view is from the southwest. Note in figure 5.7 that the ground story is below grade on the north and most of the west sides. Close comparison of figures 5.7 and 5.8 will show that the first story of the psychiatric unit collapsed so that the building now appears to be one rather than two stories in height. Note also the collapsed ambulance port south of wing D.

Figure 5.8 Olive View Medical Center after the earthquake, as viewed from the southwest.

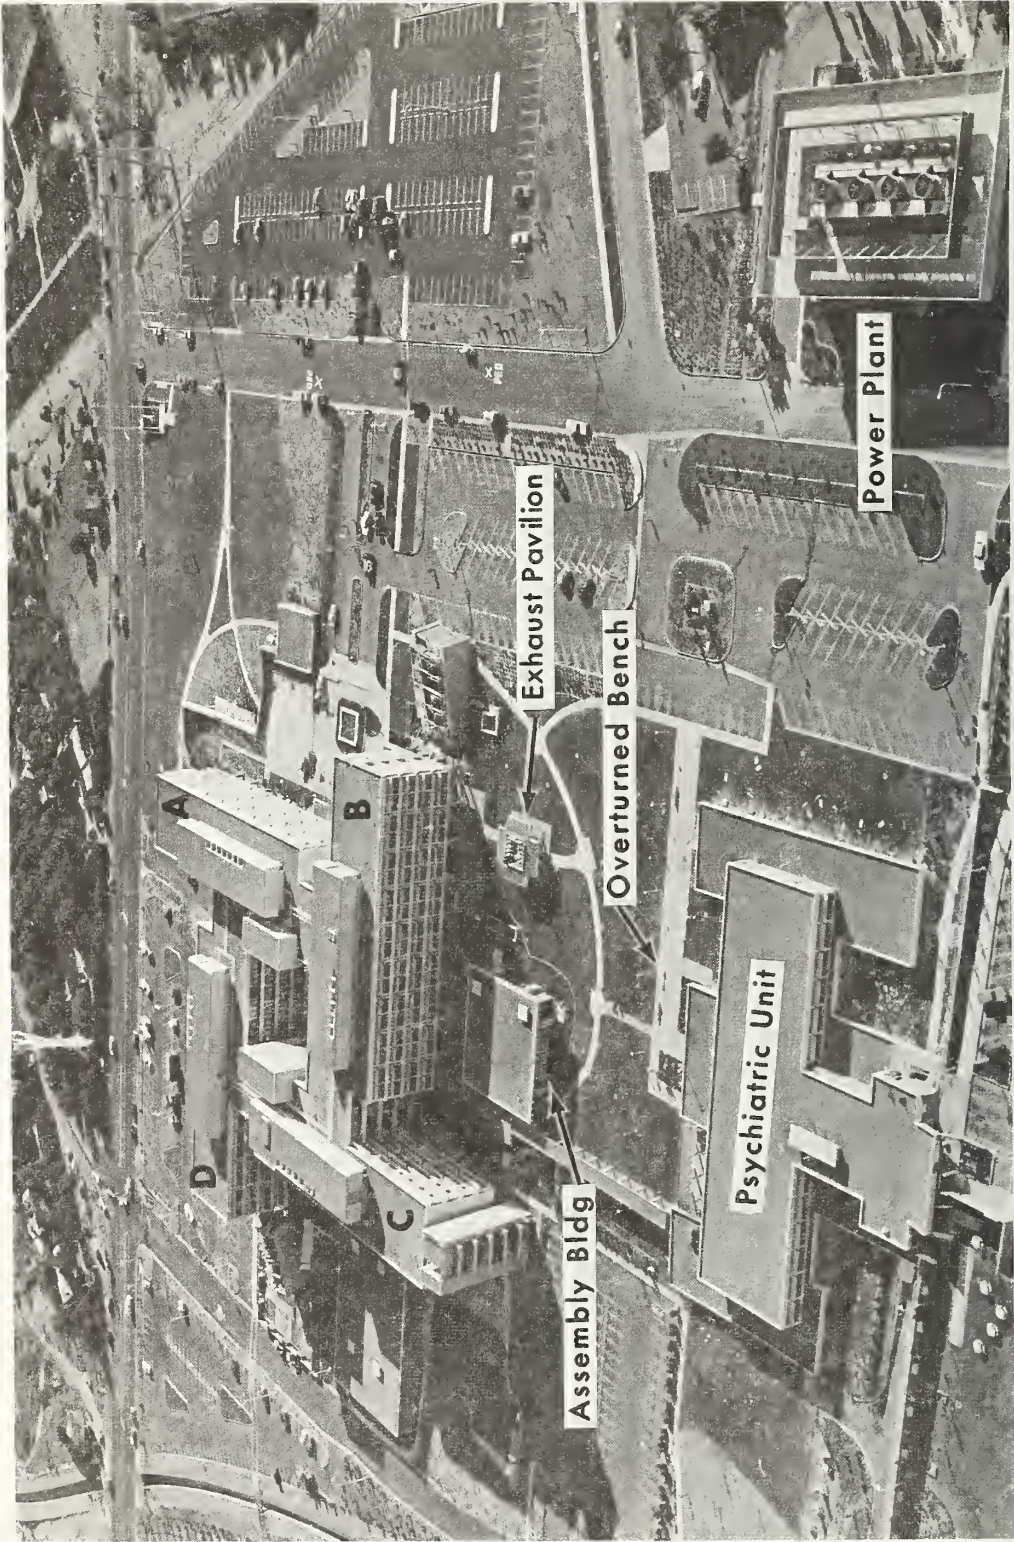
A photograph of the Medical Center as viewed from the north is shown in figure 5.9. The tipped stair tower at the end of wing C is clearly visible in this photograph. The psychiatric unit, the assembly building, the exhaust pavilion, and the power plant are also shown.

Figure 5.9 Olive View Medical Center as viewed from the north. The Psychiatric Unit which was originally a two-story structure collapsed and now appears to be a one-story building. (Los Angeles Times Photo)

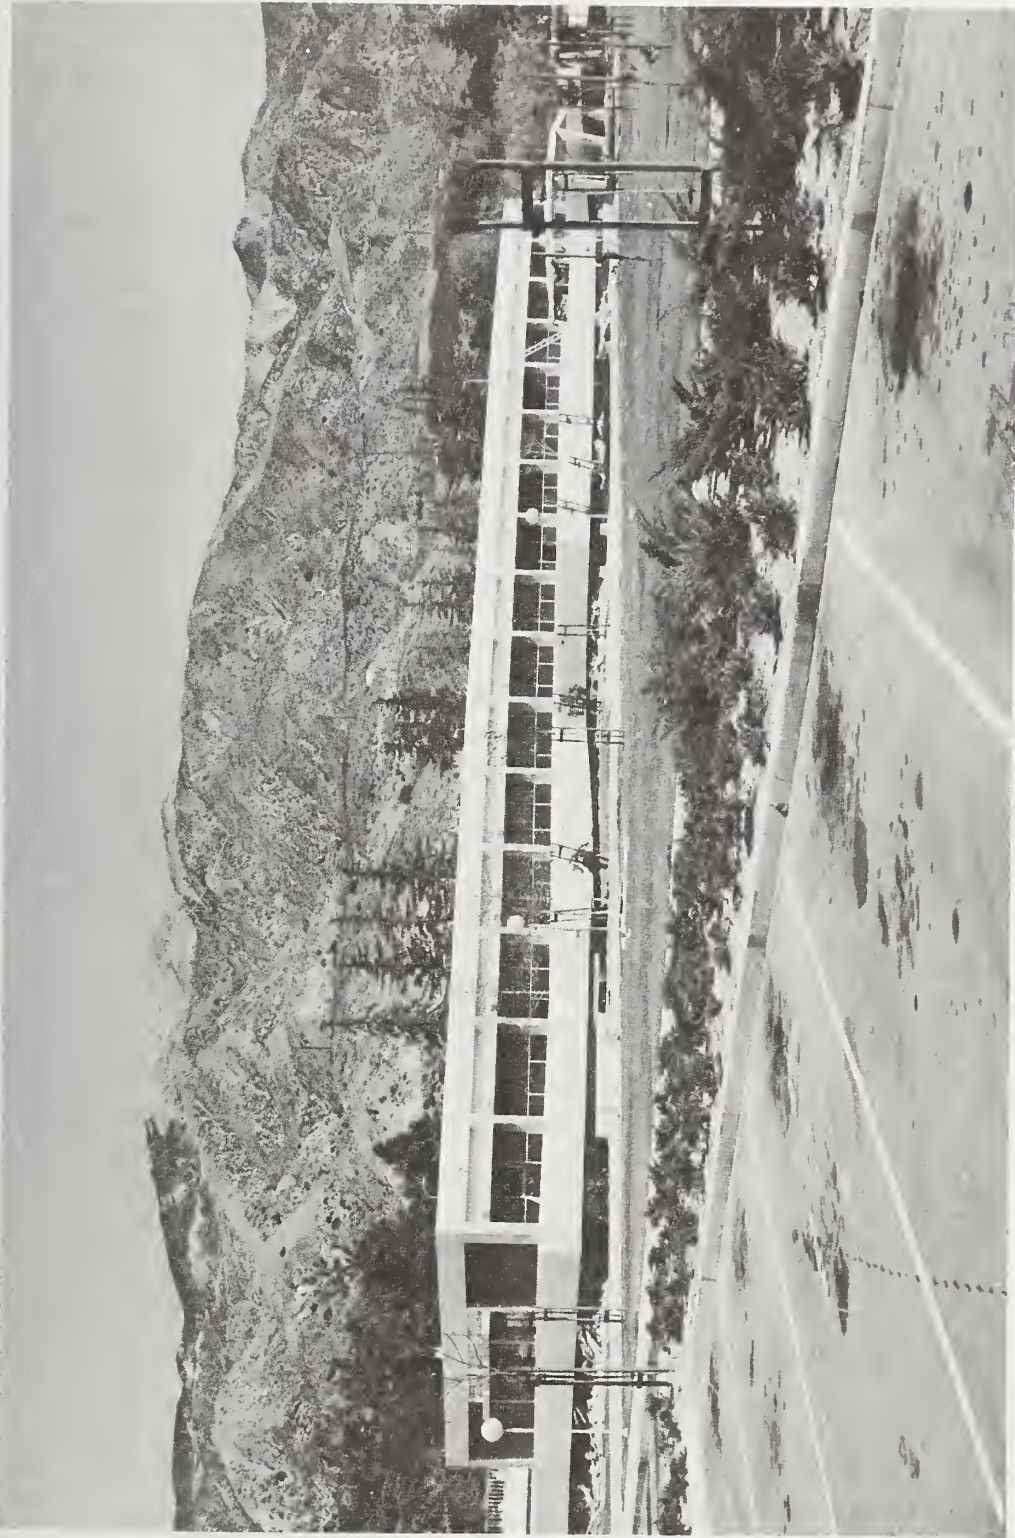
Psychiatric Unit - A photograph taken of the collapsed psychiatric unit, as viewed from the southwest, is shown in figure 5.10. As previously indicated and shown in figure 5.7, this was originally a two-story building. A plan view of the unit is shown in figure 5.11.

Figure 5.10 South and west elevations of the Psychiatric Unit. The ground story of this building was totally collapsed. What appears to be the ground floor was the first floor of this building.

The appearance of the structure after failure indicated that the columns shattered totally and pieces of lightweight concrete were hurled appreciable distances. All signs point to shear and compression failures which give virtually no ductility and so the advantages of nonlinear action and large amounts of damping in diminishing the magnitude of lateral forces are minimized.

The second floor was supported by 119 tied columns, of which 107 were 18 in by 18 in in cross section. The ties were No. 3 bars usually spaced at 18 in regardless of column size. In two instances the tie spacing exceeded the minimum column dimension. Lightweight concrete with a specified compressive strength of 3000 psi was used above the first floor. Design was based on working stress design using the general provisions of ACI 318-56 [5.5], which was the procedure in the Los Angeles County Code during the period (1965) that this particular structure was designed. This design basis provides a possible key to the collapse of the first story.

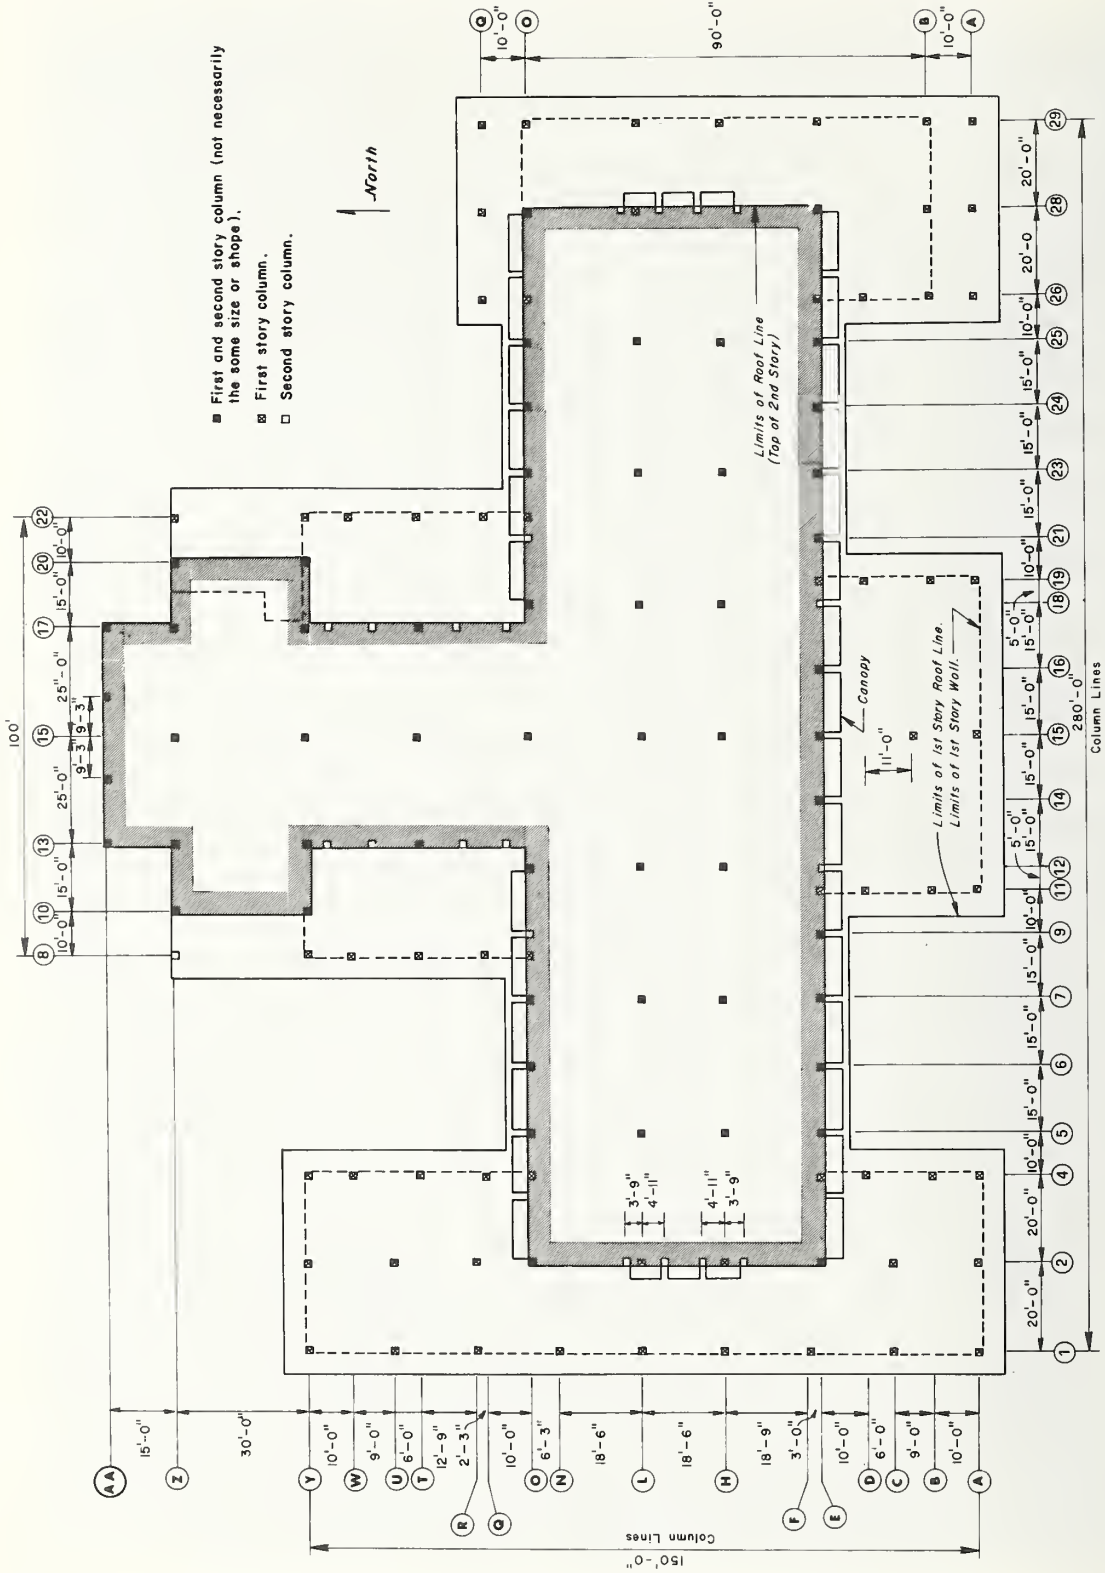
Figure 5.11 Floor plan of Psychiatric Unit.

As an example of the consequences of this overly large shear stress, consider the case of column 20Z (see fig. 5.11 for location). This column had computed design shears of 17,500 lb in the north-south direction and 10,600 lb in the east-west direction for code values of lateral forces. These shears are complicated by the fact that this is a case of biaxial shear, in that very large simultaneous accelerations were noted in both the north-south and east-west directions. Hence, it is quite possible that the column was under extremely high combined shear stresses. The column

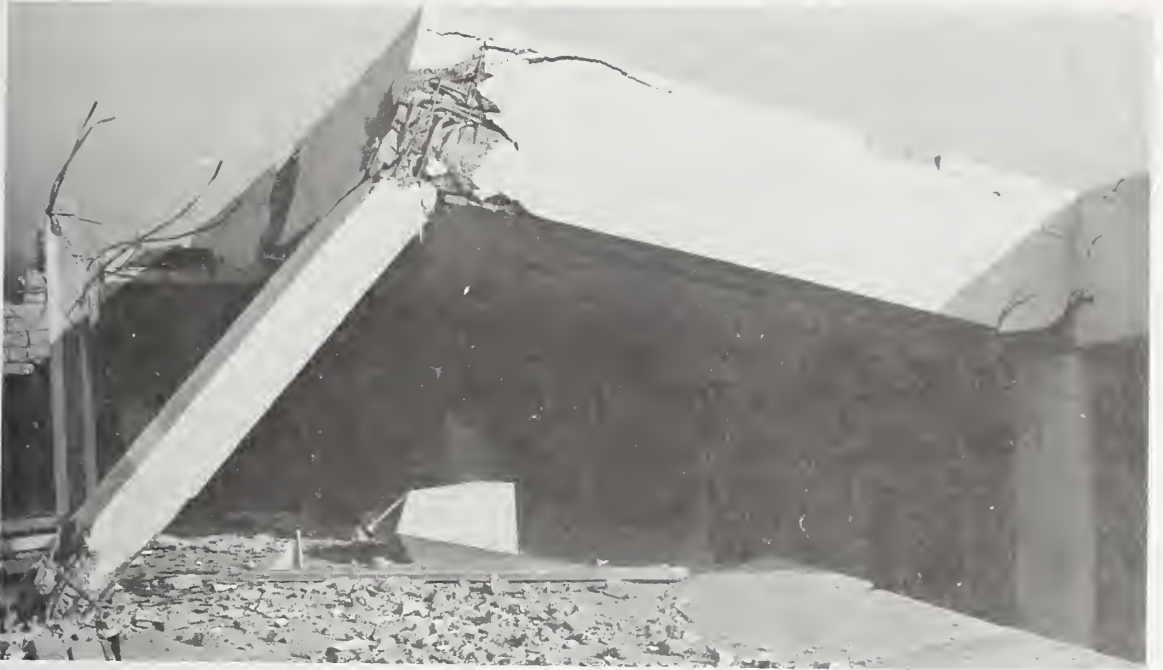
Evidence of ground motion is shown in the photograph of the west elevation of the psychiatric unit in figure 5.12. A close-up of the north entrance indicated in figure 5.12 is shown in figure 5.13. Figure 5.14 shows an overturned bench (see fig. 5.9 for location) which was bolted to the sidewalk, located south of the psychiatric unit. Calculations, which neglect the bolts, indicate that a horizontal ground acceleration of at least one-half gravity was required to overturn the bench. Similar calculations made on an overturned tombstone about three blocks south of Olive View indicated that a horizontal acceleration of one-half gravity or a horizontal acceleration of one-third gravity accompanied by a vertical acceleration of one-third gravity might have occurred in that general vicinity.

Figure 5.13 Damage to the canopy at the front (north) entrance to the Psychiatric Unit.

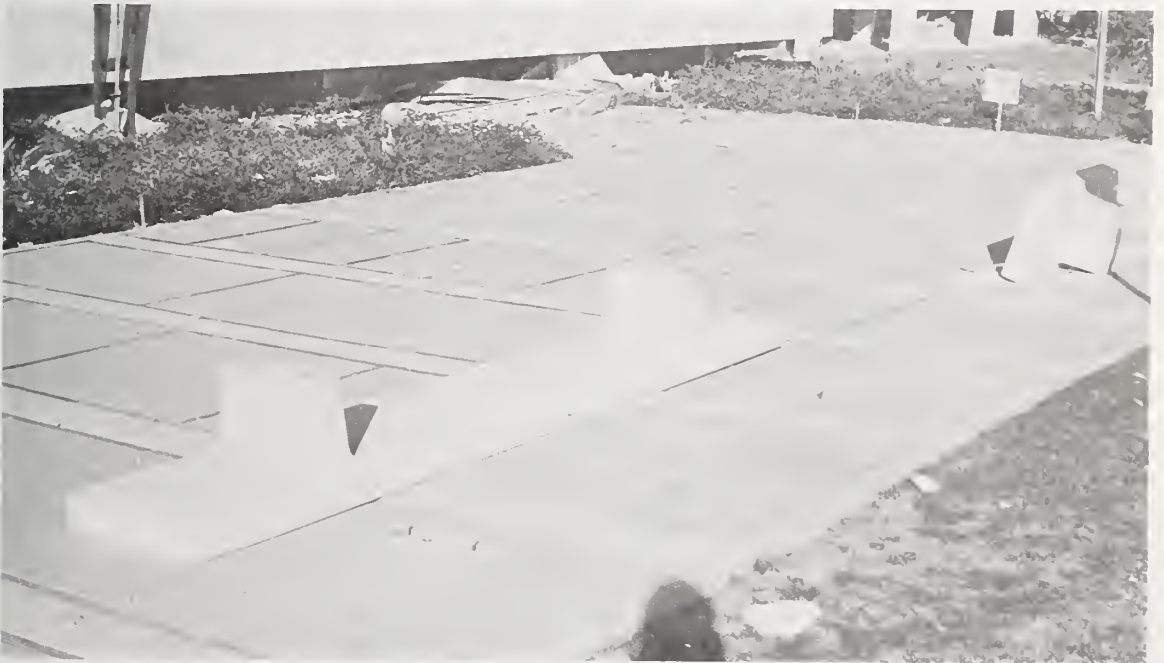
Figure 5.14 This overturned concrete bench, which was bolted to the sidewalk, is located south of the Psychiatric Unit.

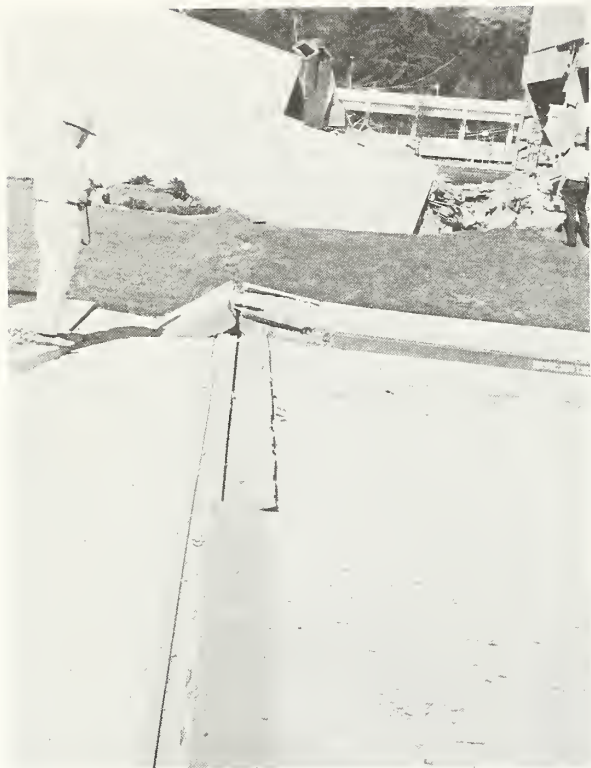
Figure 5.16 Compression ridge on the west side of the main building. A toppled stair tower is visible in the background.

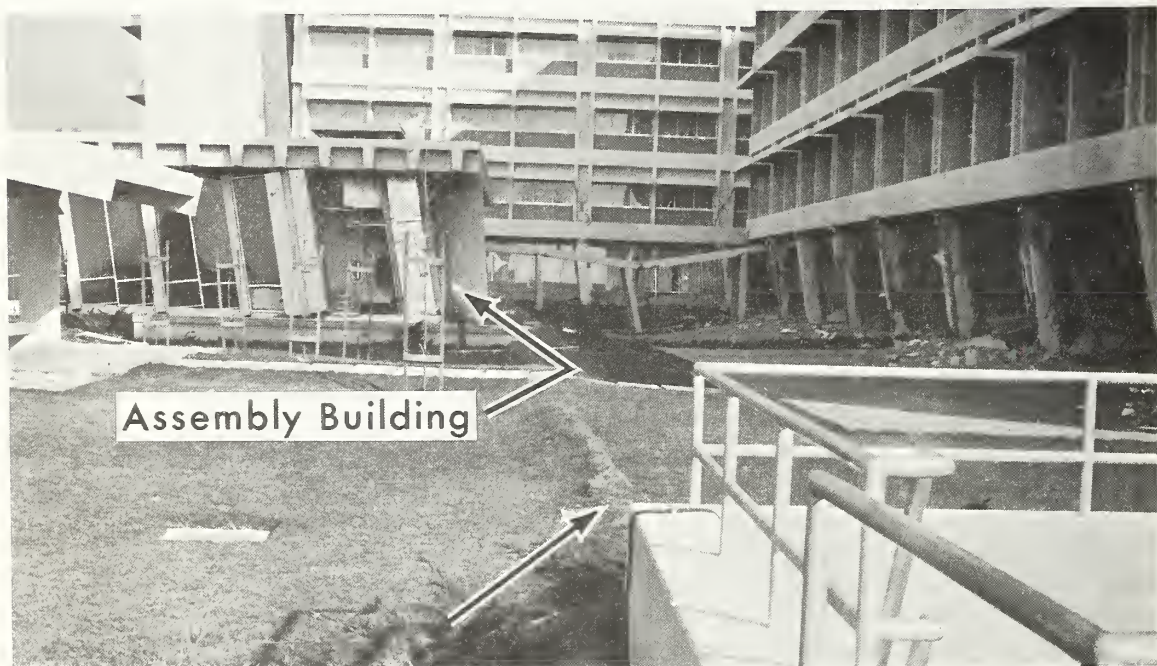
Figure 5.17 Compression ridge (arrow) on the north side of the main building.

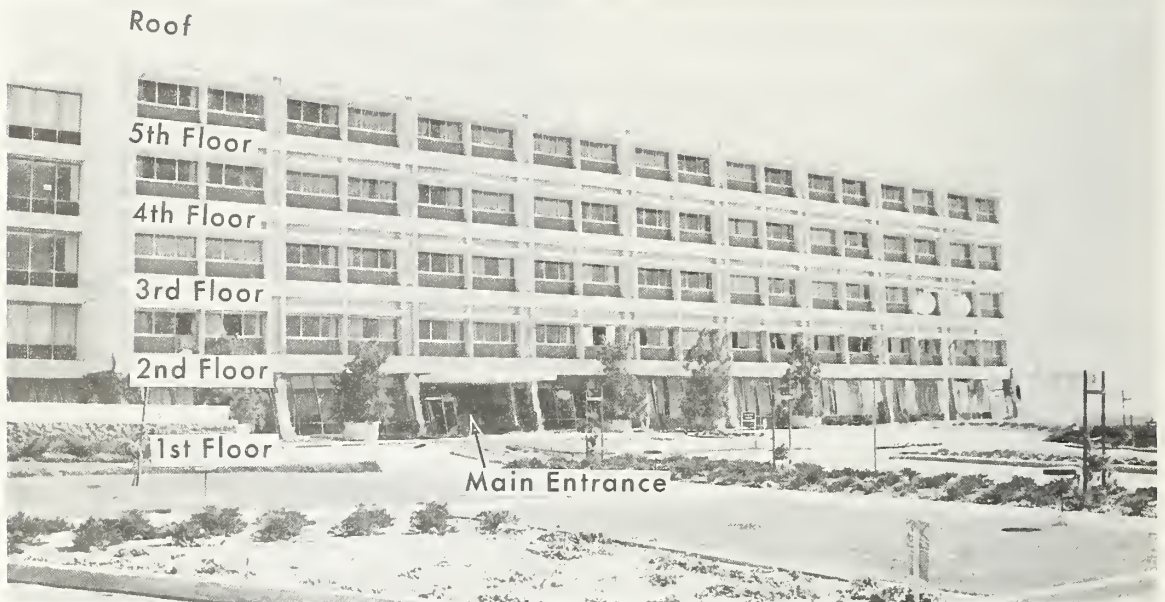
The west face of Wing A is shown in figure 5.18. This view shows the large lateral displacement of the wing to the north. Most of the displacement is in the first floor. This is shown clearly in the photograph of the main entrance in figure 5.19 (location shown in fig. 5.18).

Figure 5.18 West face of Wing A. Note the extensive damage at the first floor and the lateral displacement of the building to the north. Most glass was intact in windows above the third floor.

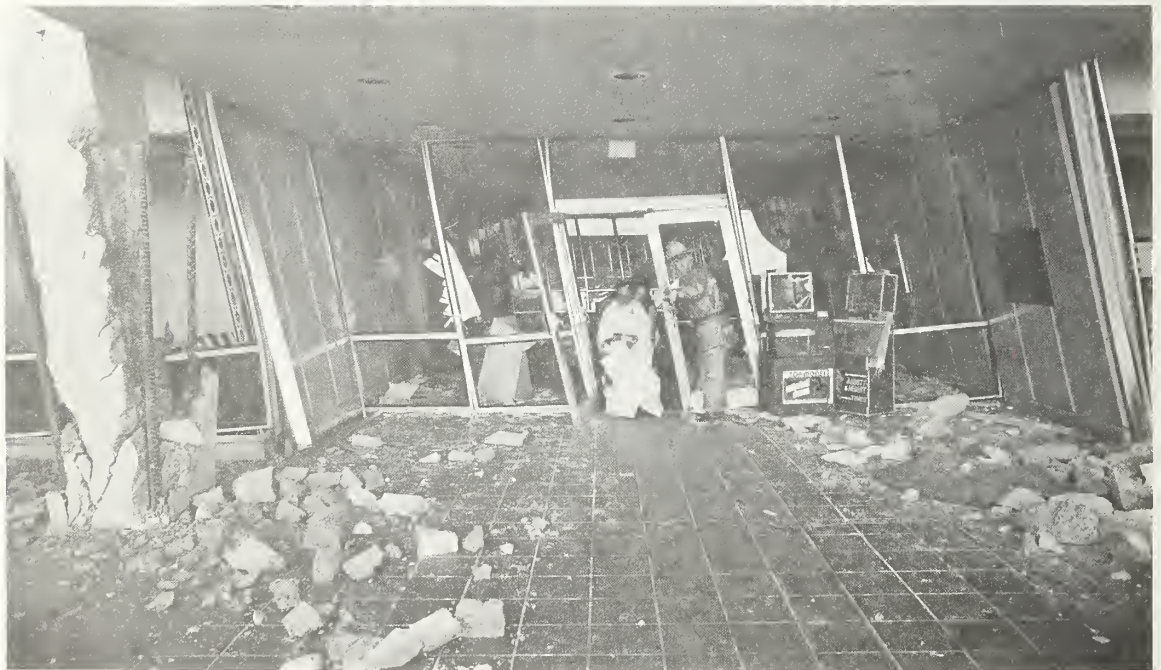
Figure 5.19 Patient evacuation through the main entrance of Wing A. (Los Angeles Times Photo)

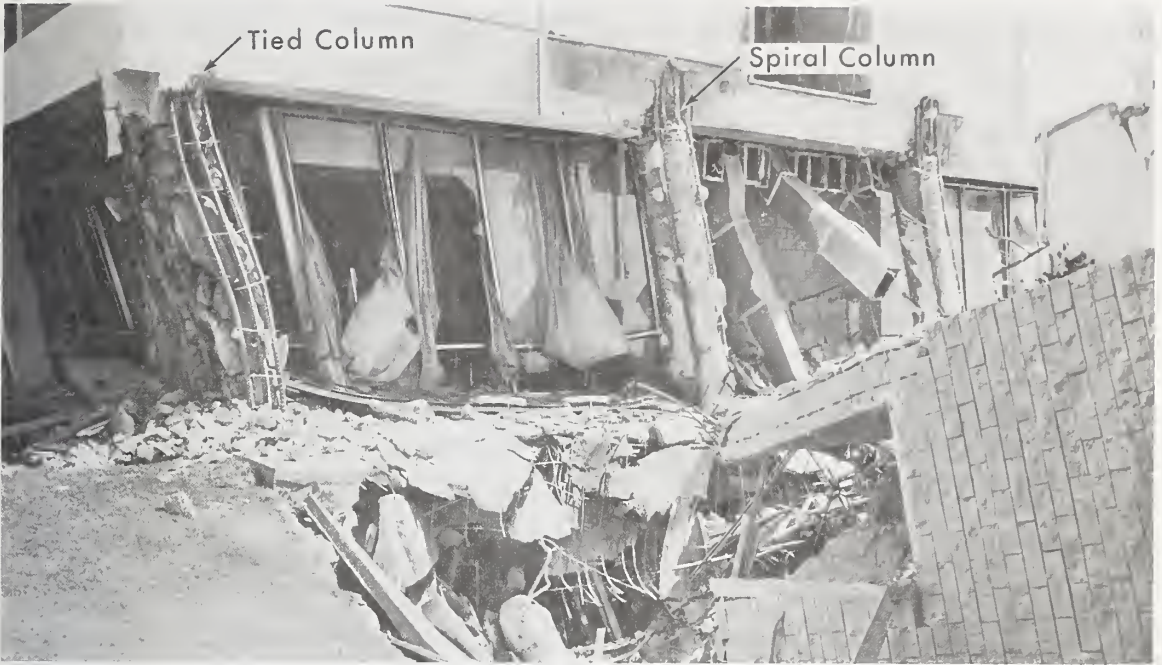
A typical first-story tied corner column is shown in figure 5.20. Note that this column was completely shattered and incapable of resisting load. Vertical bars in some similar columns actually fractured as shown in figure 5.21. On the other hand the spiral columns shown in figure 5.20, although having undergone tremendous lateral displacements, were still capable of carrying load. However, it is doubtful that they could have withstood much more strong ground motion.

The corner column in figure 5.20 had a design shear of 75 kips in the east-west direction and 108 kips for shear in the north-south direction for building code lateral force values. The L-shaped column has about 880 sq in of area and probably 800 sq in effective for shear. The tie spacing of No. 3 bars at 18 in is so large that the ties cannot count as shear reinforcement. This means the shear stresses in the north-south direction are approximately 135 psi and in the east-west direction 93 psi. These have a vector sum of approximately 160 psi. This shear stress would compare to the 1956 ACI allowable value (without a 33 percent overload allowance) of 90 psi, and 1963 ACI Code allowable value of approximately 80 psi for working stress and approximately 120 psi for the ultimate shear stress of 5000 psi concrete. This is based on the relatively low code acceleration coefficient of about 8 percent which was used in design. This indicates that this column was on the borderline of adequacy under the then existing Los Angeles County Code requirements and would be inadequate if biaxial shear effects are considered. There is no mention in the code of such biaxial shear effects. When the more restrictive 1963 ACI Code shear provisions are considered, the column would be clearly insufficient for the design lateral forces. Had the County Code been revised to include the 1963 ACI Code provision, additional lateral reinforcement would have been clearly required in this column.

Figure 5.20 West end of Wing B. Note the contorted column and the extent of the northward drift of the building. In the right foreground is the base of the toppled stair tower. Note that this stair tower has collapsed through the roof of the ground story.

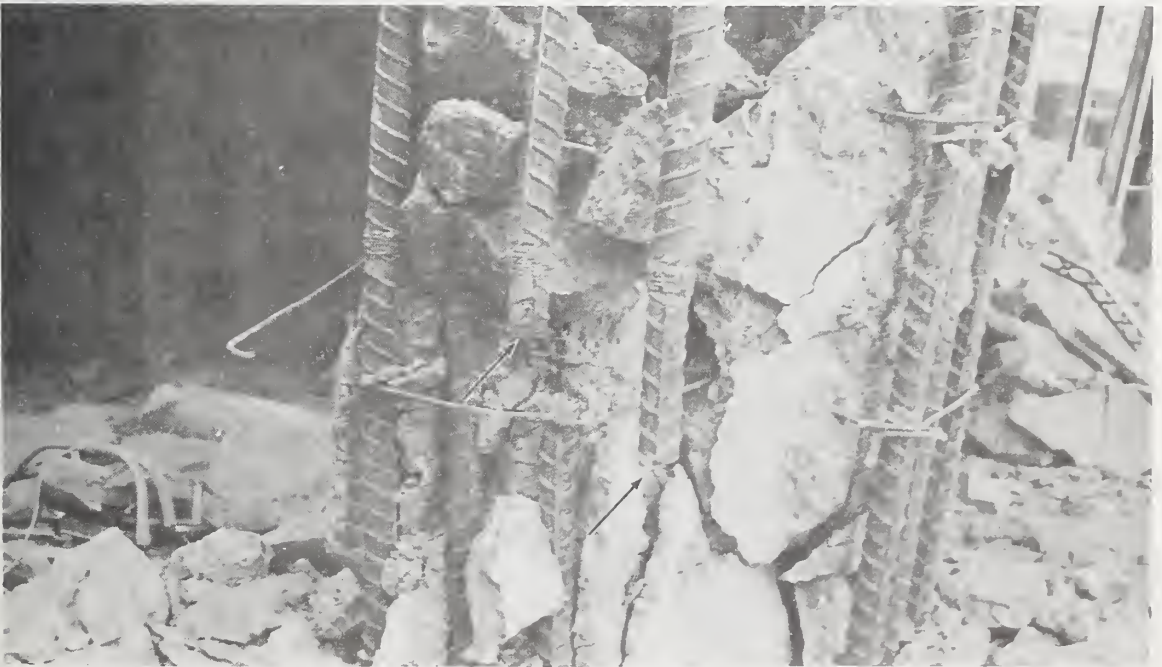
Figure 5.21 Close-up view of the first story column in the northeast corner of Wing B. Note the two fractured main reinforcing bars (arrows) and broken ties.

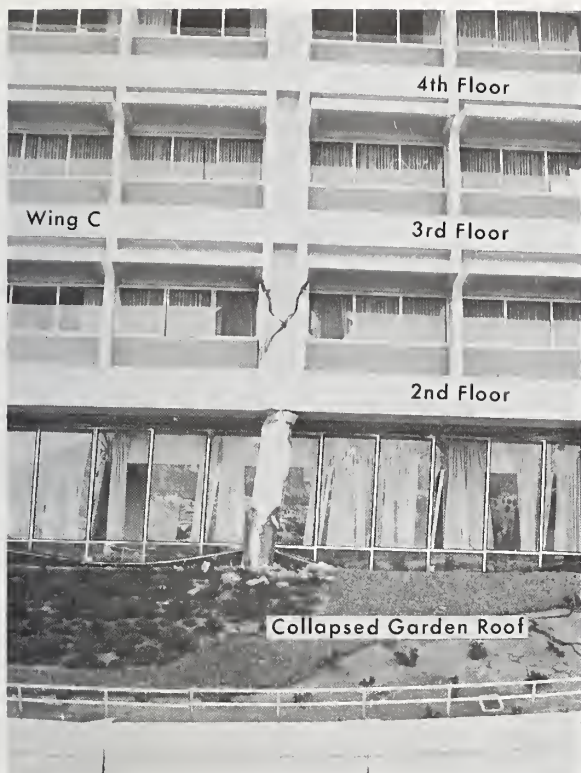
The east face of Wing C is shown in figure 5.22. Again the lateral displacement of the building to the north in the first floor can be seen. Note the diagonal cracking in the second-story C-shaped columns which indicates that the column was subjected to load reversal.

What appears to be an embankment in the foreground of figure 5.22 is actually a collapsed garden roof. This type of failure is shown more clearly in figure 5.23, the south face of Wing D. The garden roof which is an extension of the first floor, can be seen in its collapsed position. One hospital employee was killed at this location. Several protruding ground-story columns which originally supported the garden roof are indicated by arrows. A close-up view of one of the failed ground-story columns which originally supported the roof is shown in figure 5.24. A photograph of a ground-story column with the top completely stripped of reinforcement is shown in figure 5.25. The extensive column damage at the first floor is typical of column damage found at the first floor in all wings of the hospital.

Figure 5.22 A portion of the east face of Wing C. The collapse of the garden roof as well as the extensive damage of the first floor columns can be seen. Note the lateral displacement of the building to the north, in the first story and diagonal tension cracks in the second-story column.

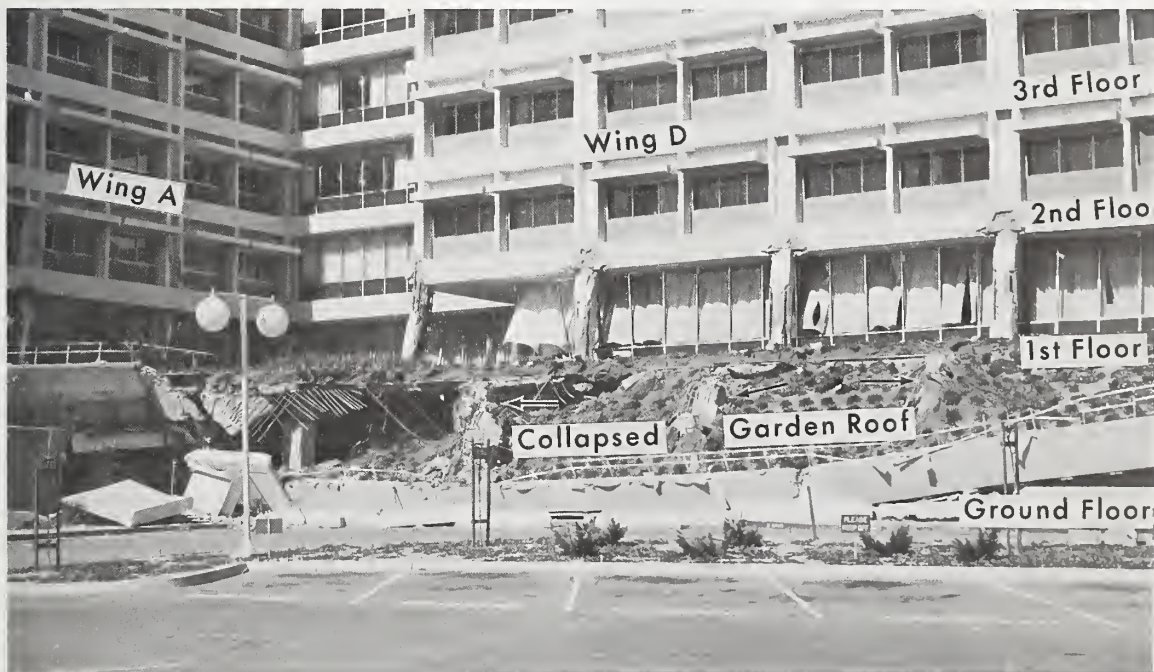
Figure 5.23 South face of Wing D. Note that the bulk of major damage suffered by the building is limited to the ground, first, and second floors.

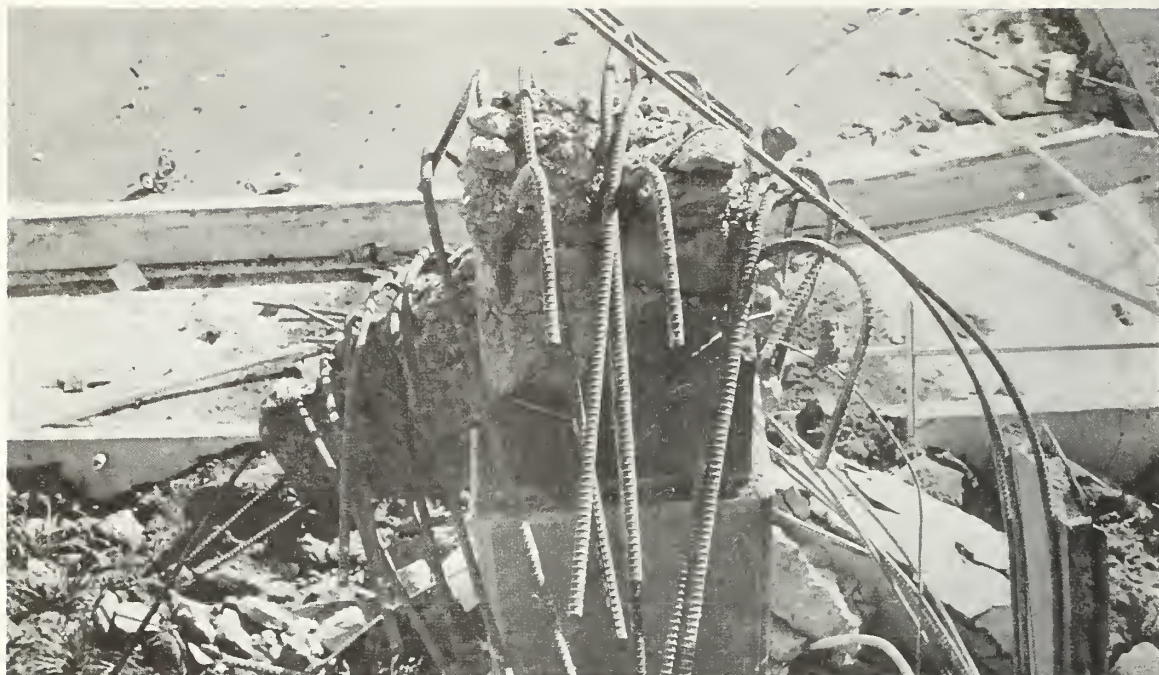
Figure 5.24 Close-up view (looking south) of one of the failed ground-story columns which originally supported the first-floor garden roof in front of Wing D. This is the same column seen in figure 5.23, the third from the right.

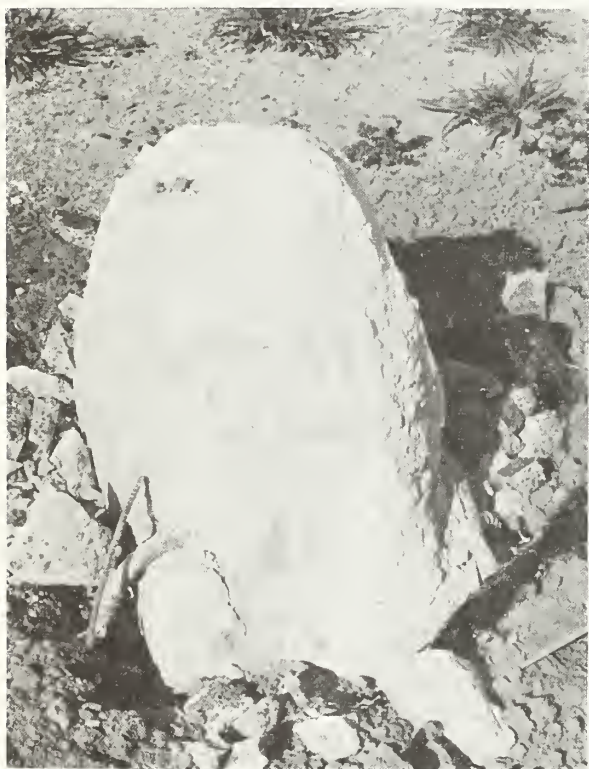
Figure 5.25 A column protruding through the garden roof at the far east end in front of Wing D. Note that in this failure the reinforcement has been completely peeled away from the upper end of the column.

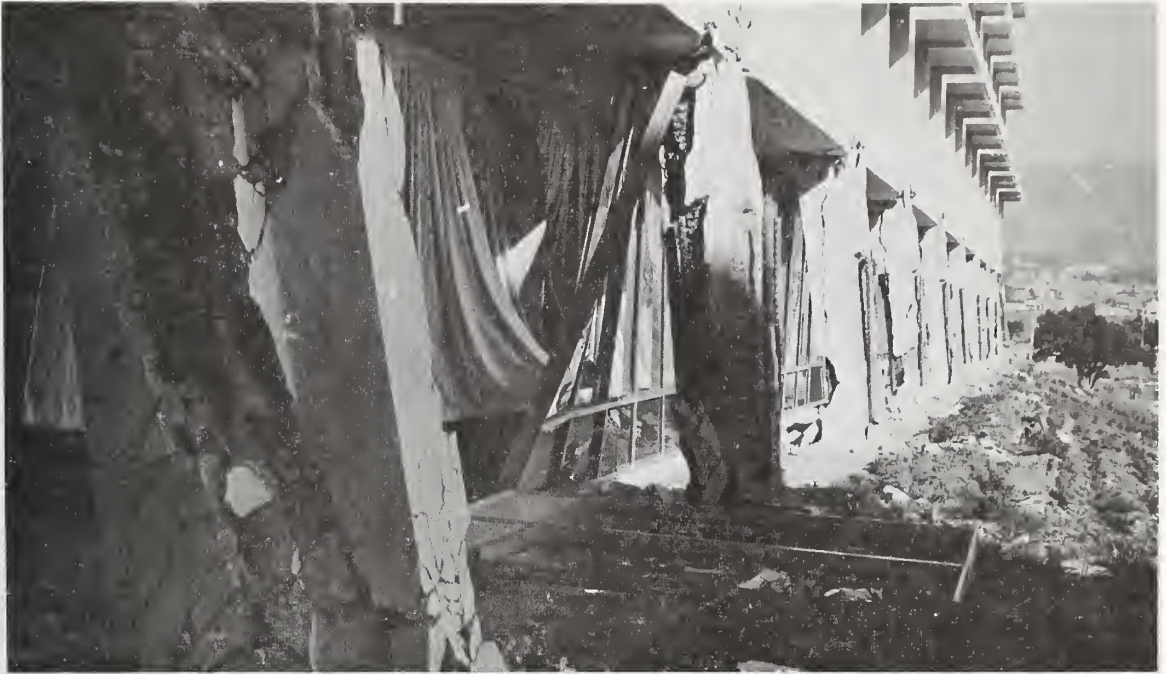
The south row of first-story columns in Wing D is shown in figure 5.26. The first column to the left is the L-shaped corner column. The remaining columns immediately visible to the right are spiral columns with a No. 18 bar in each corner running about two-thirds of the way up the column height. These bars, which are continued from the story below, have broken out of the column corners. These bars were not confined by spirals or ties, contrary to code requirements.

Figure 5.26 South row of first story columns, in Wing D; note the lack of ties on the corner bars which have broken out of the columns.

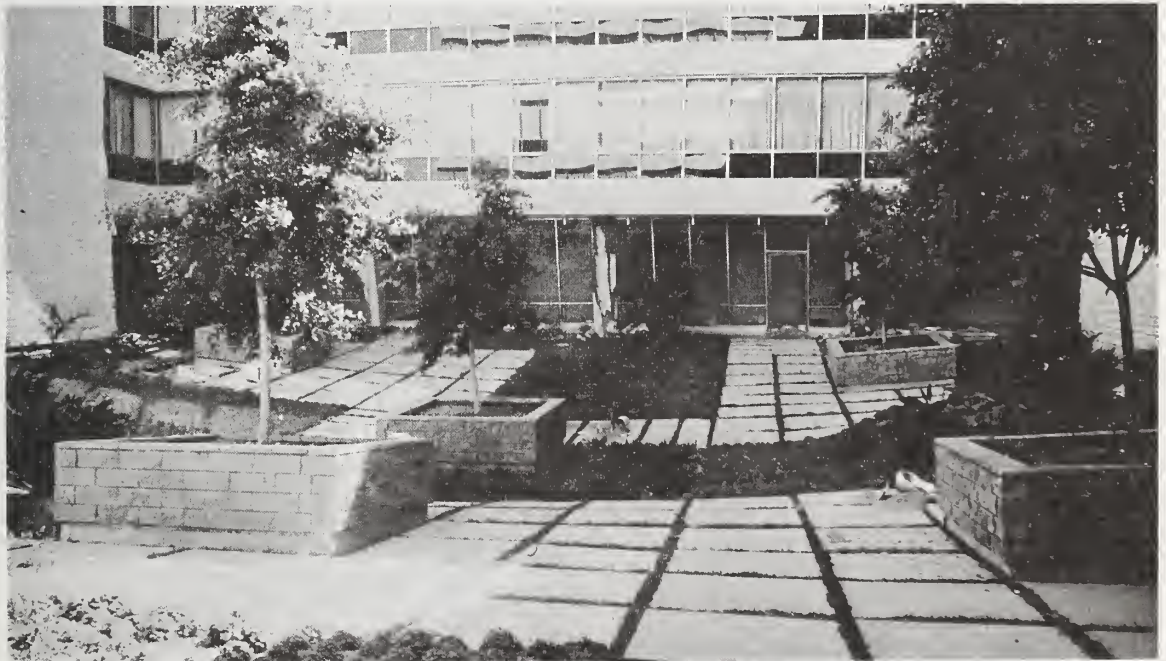
The enclosed first-floor court formed by the four hospital wings, is shown in figure 5.27. The sagging of the court was caused by failure of the ground-story columns. Other interior photographs are shown in figures 5.28, 5.29 and 5.30.

Figure 5.27 Enclosed court at the first floor level. The sagging court was caused by failure of the ground-story columns.
